Detail Project Report

Condition Assessment of UCO Bank Building

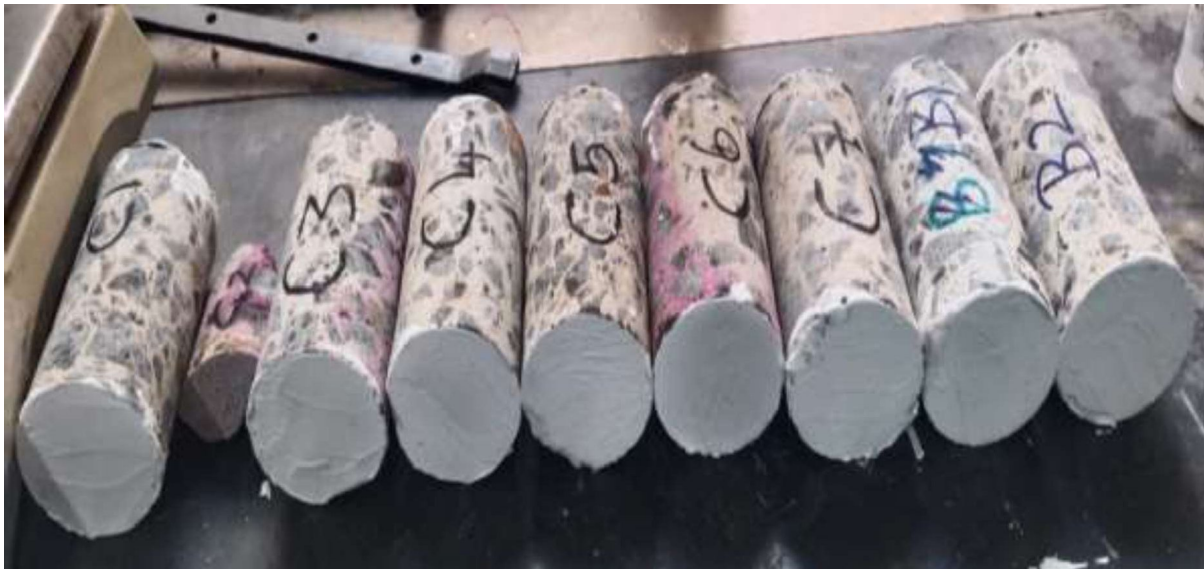
Figure.1 Concrete core samples

NOTE: On thorough examining the concrete cores (Fig. 1), the coarse aggregate presence is predominant when compared to fine aggregates. Due to the above fact the rebound hammer hits the aggregates and the rebound number is excessively in higher side based on which the conclusion cannot be made and it can be considered as additional result only.

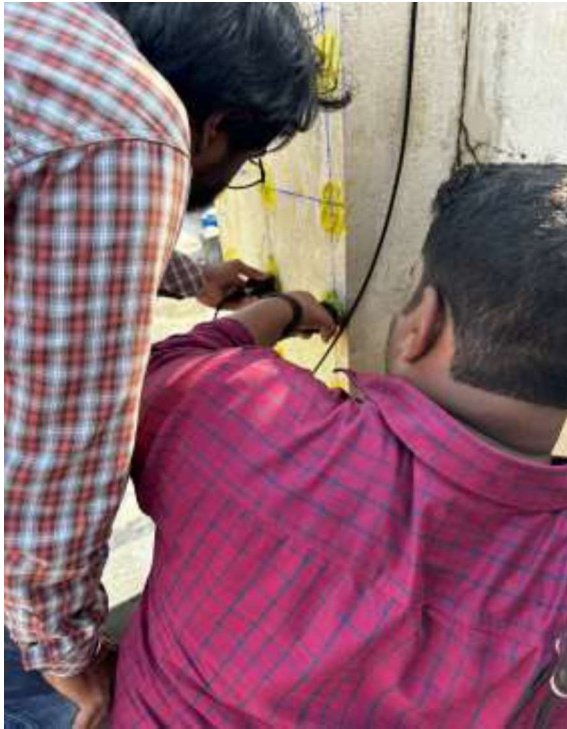
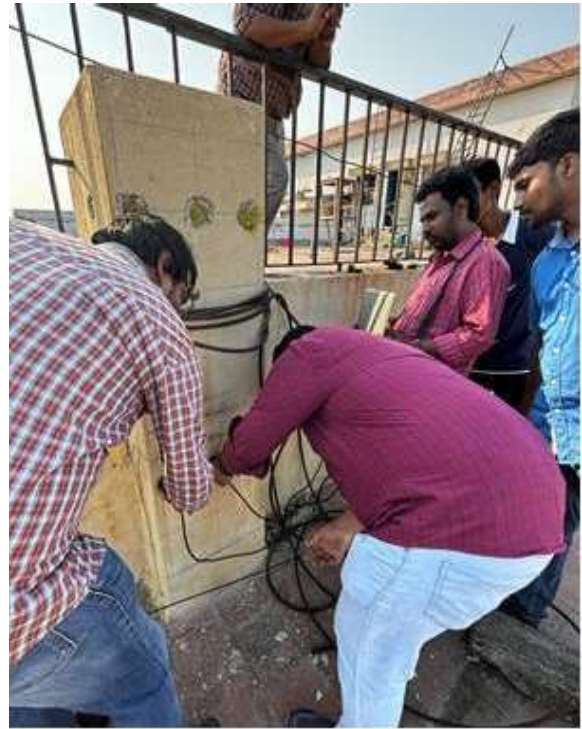
Figure.10 UPV test at location C1 & C1

Based on ultrasonic pulse velocity test, the integrity of the concrete at tested locations were in good conditions (Table 2) as the mean velocity is higher than 3750 m/sec. Carbonation at terrace corner column which was fully exposed to the outside environment (C2) has significant impact of carbonation with average depth of 22 mm. The other tested samples like C3 and C6 has least impact of carbonation which was due to partial exposure to outside environment. Each concrete core samples were tested in compression testing machine (CTM) based on which the compressive strength of each specimen was found. The least and average strength was found to be 15 N/mm² and 26 N/mm² respectively. The least strength

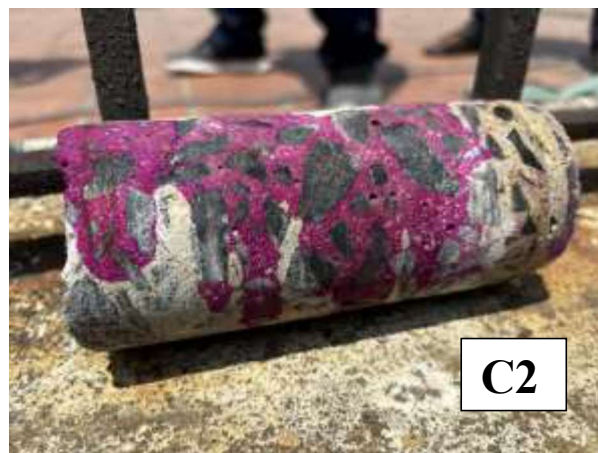
Figure 16. Carbonation test conducted at site for C2 sample

The exterior column concrete core C2 & balcony column concrete core C3 were tested for carbonation at site (Fig. 16 & 17). The depth were measure at site for both samples. For furthur confirmation, the carbonation test was carried out in the laboratory by breaking the concrete core samples into two haves by means of split tensile test (Fig. 18). Since the sample were broken into several perices, a small pieces from the surface side were taken and tested for carbonation. The depth of carbonaiton were measure using scale as shown in Fig. 19. The avergae depth of carbonation for sample C2, C3 & C6 were found to be 22 mm, 12 mm and 9 mm respectively [Table 5].
