Detail Project Report

Condition Assessment of UCO Bank Building

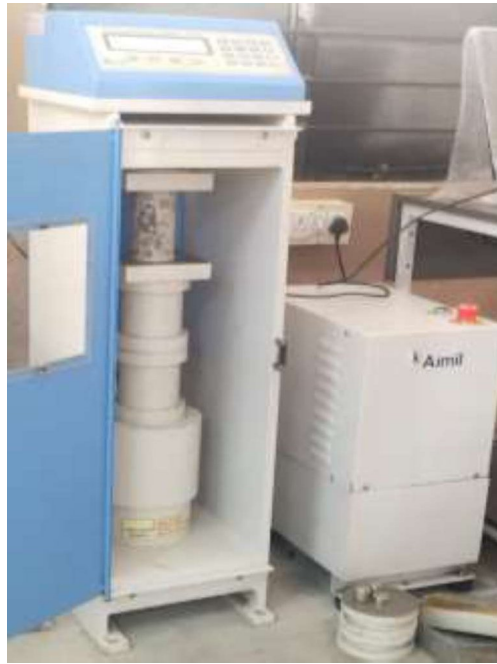
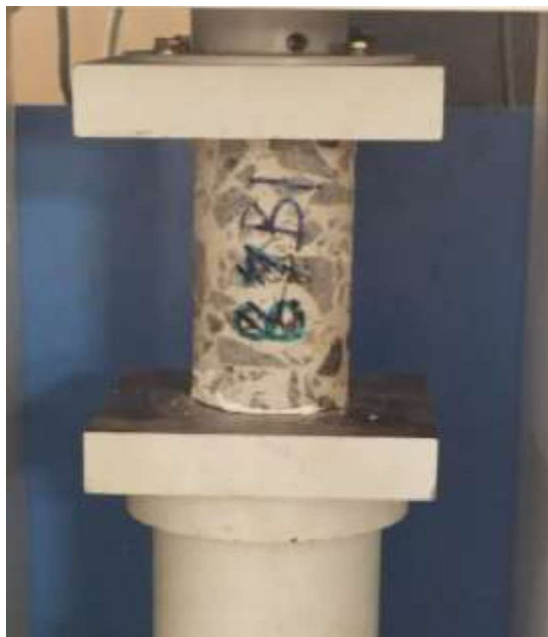
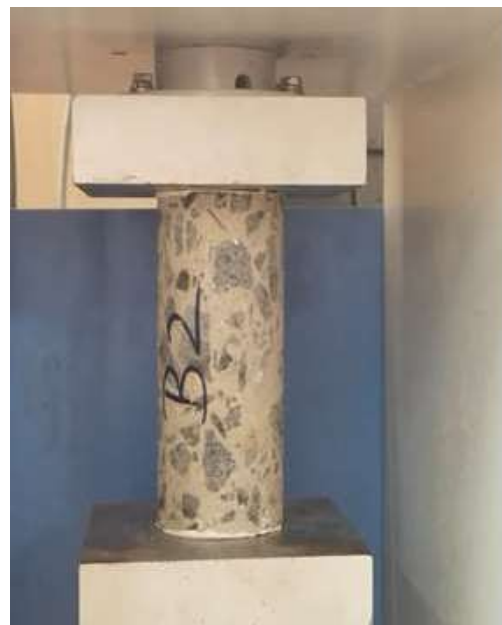
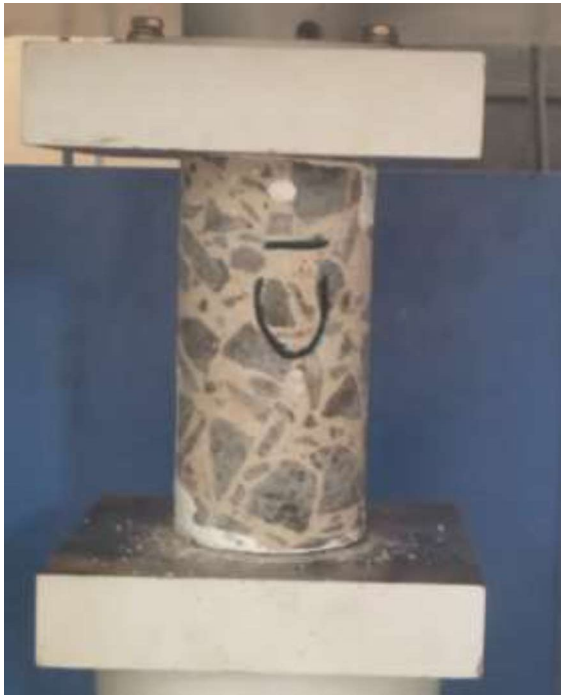
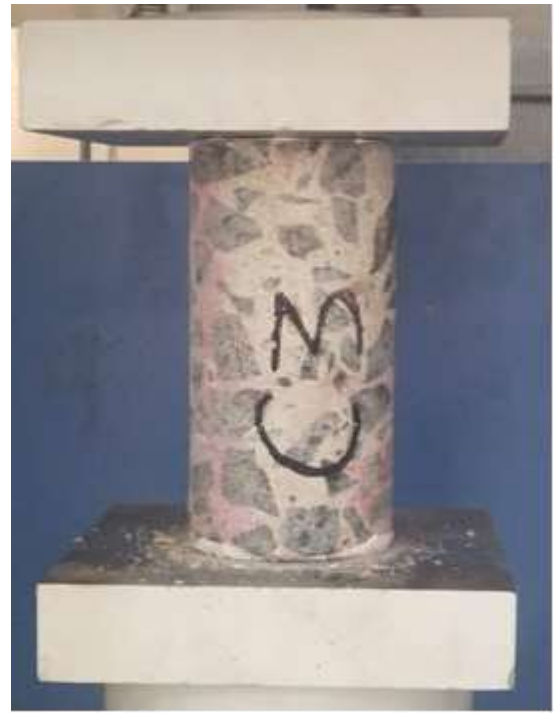
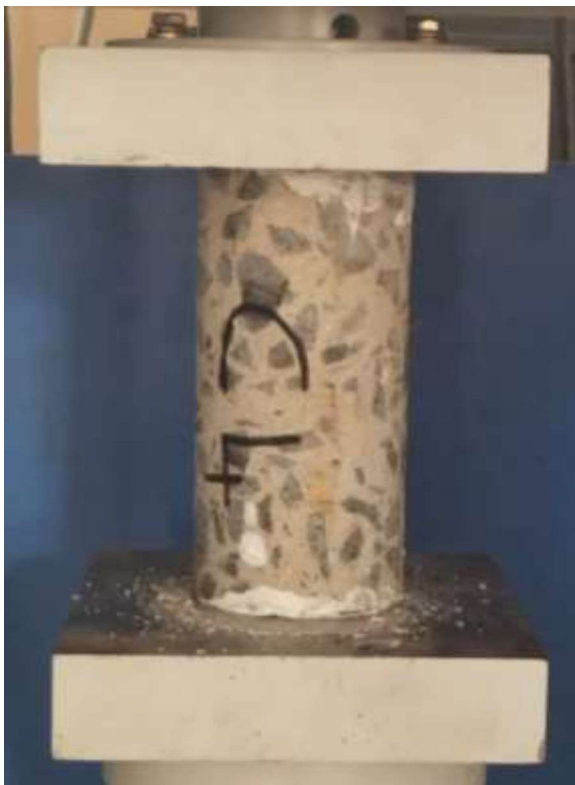
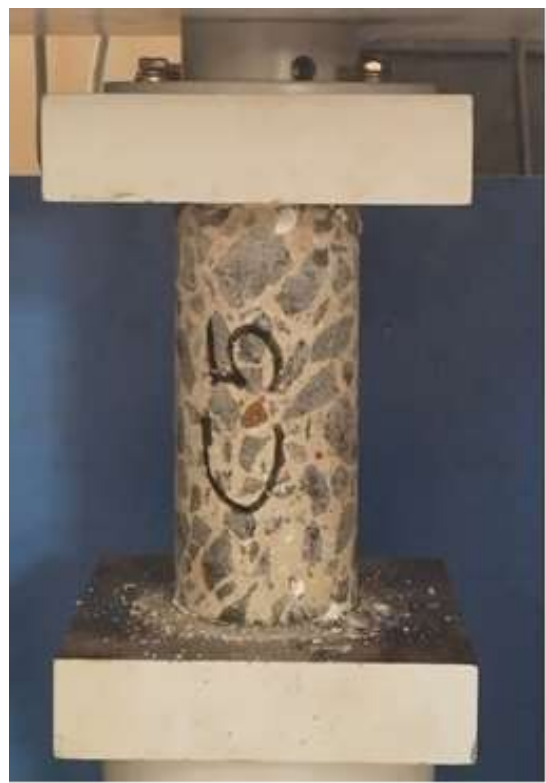
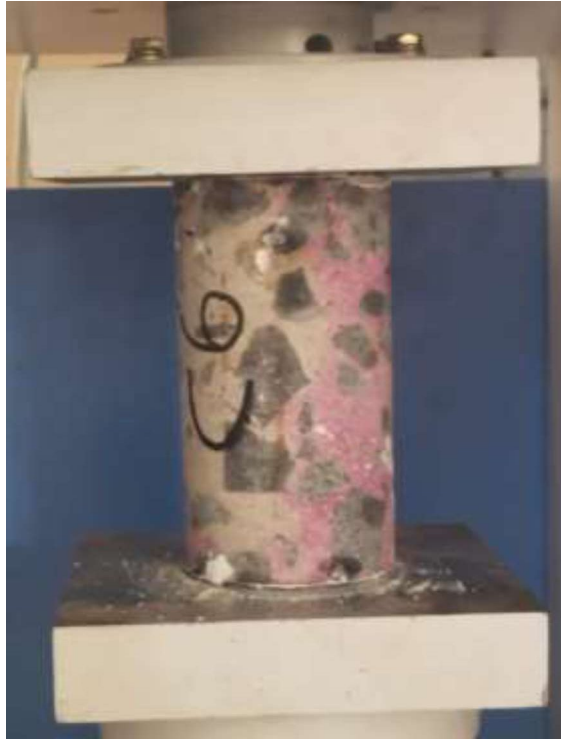
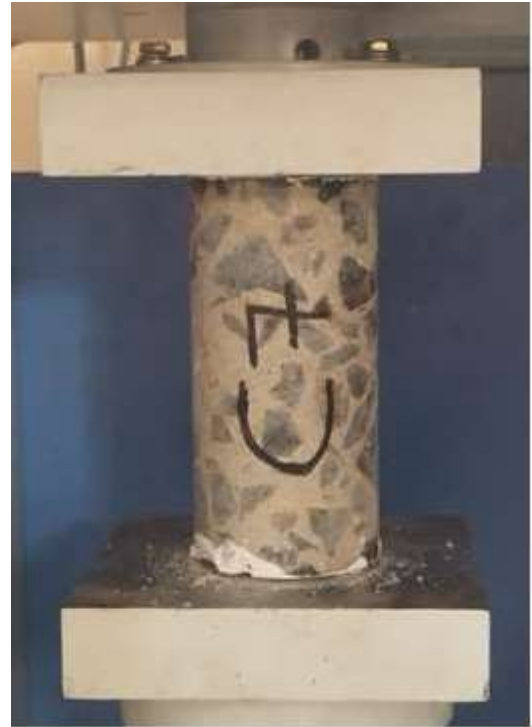
Figure.12 (a) to (i) Compression test of Concrete core samples using CTM

The concrete core samples were test for compressive strength using compression testing machine (CTM) as shown in Fig. 12 (a). At constant loading rate the concrete core were tested [Fig. 12 (b) to 12(i)] and the final load capacity were tabulated [Table 5]. The exterior column sample C1 shows lesser compressive strength when compared with other tested samples. This may be due to the impact of carbonation. The compressive strength of each tested samples were found by dividing with the area of cylinder and the resulted values were converted with respect to cube compressive strength.

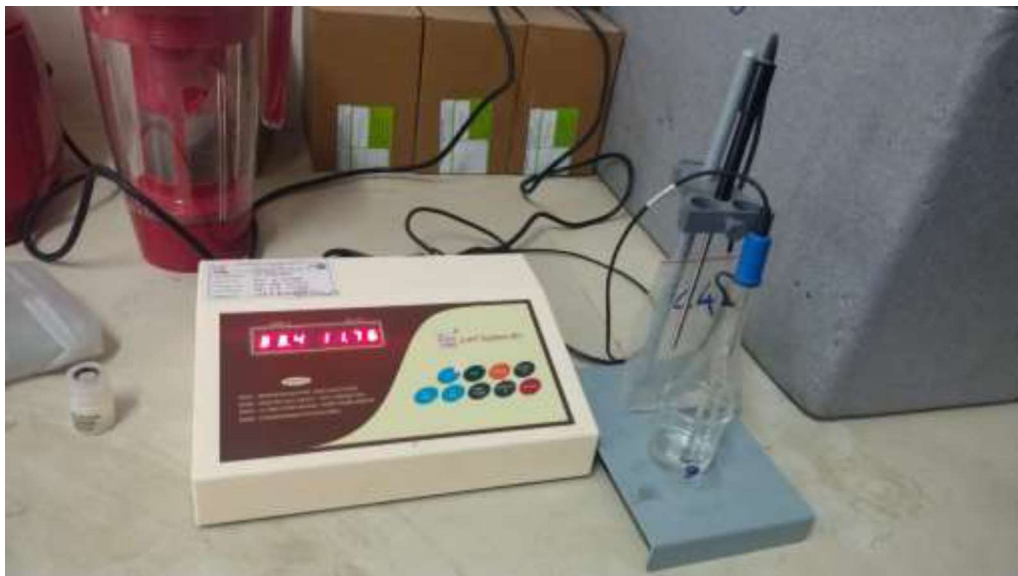
Figure.13 pH experimental setup at lab

As mentioned in section 4.5, the pH of the concrete were found for each concrete samples shown in Table 4. The experimental set up for pH test is shown in Fig. 13. The samples prepared were shown in Fig. 14 and testing of samples is shown in Fig. 15. The pH values shows that the concrete retains its alkalinity to a greater extent [Table 5].

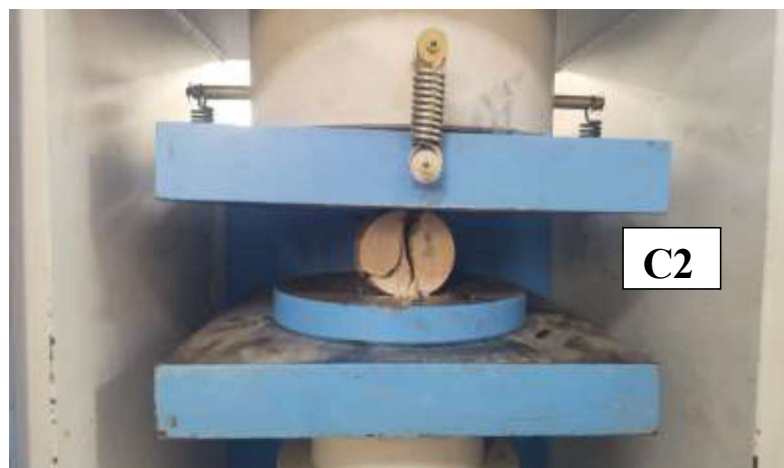
Figure.18 Split tensile testing of core cut sample for carbonation test

The exterior column concrete core C2 & balcony column concrete core C3 were tested for carbonation at site (Fig. 16 & 17). The depth were measure at site for both samples. For furthur confirmation, the carbonation test was carried out in the laboratory by breaking the concrete core samples into two haves by means of split tensile test (Fig. 18). Since the sample were broken into several perices, a small pieces from the surface side were taken and tested for carbonation. The depth of carbonaiton were measure using scale as shown in Fig. 19. The avergae depth of carbonation for sample C2, C3 & C6 were found to be 22 mm, 12 mm and 9 mm respectively [Table 5].
